Whitstone Parish Public Rights of Way (PRoW) – Survey 2011

Mike Sutton (Footpath Co-ordinator)
Whitstone Parish Council
22/7/2011

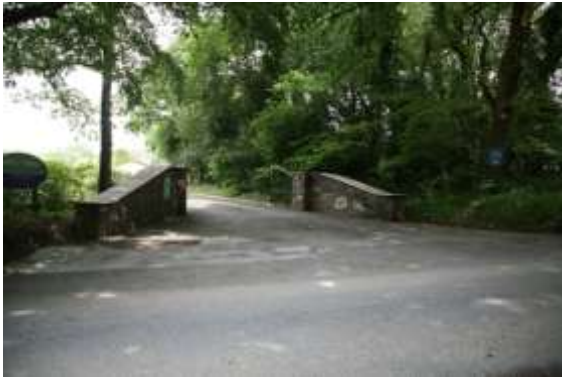
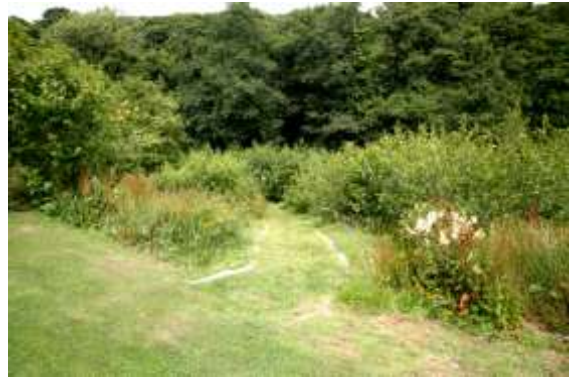
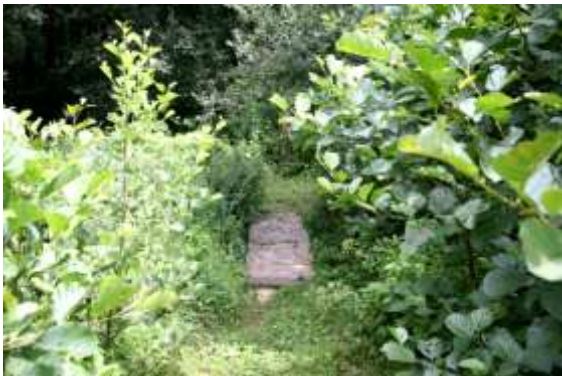
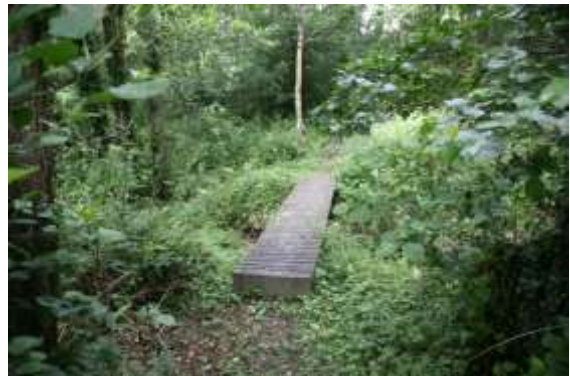
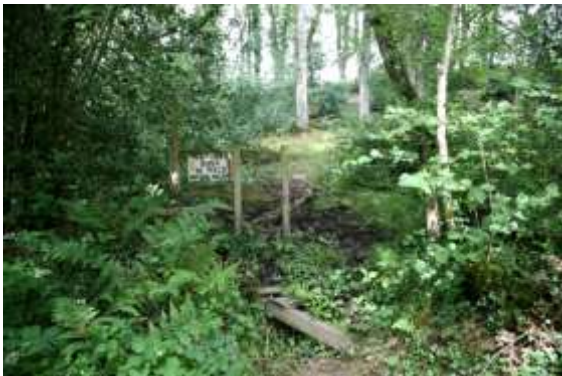
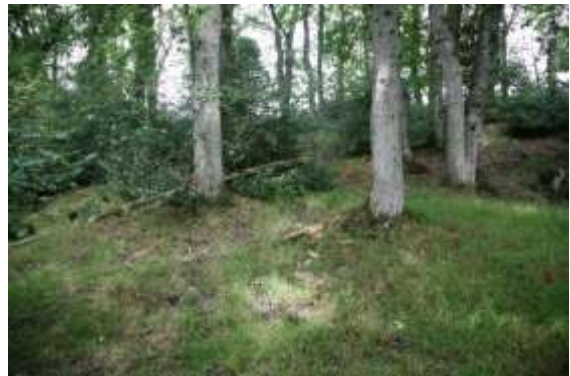
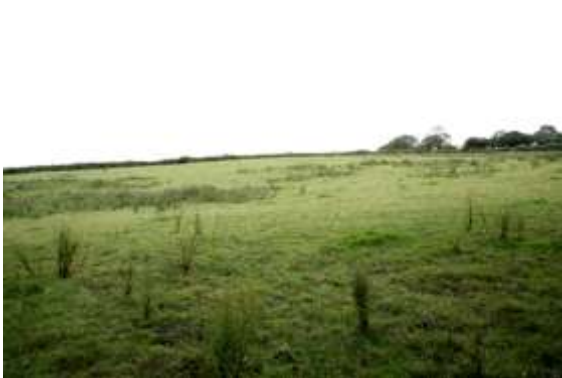
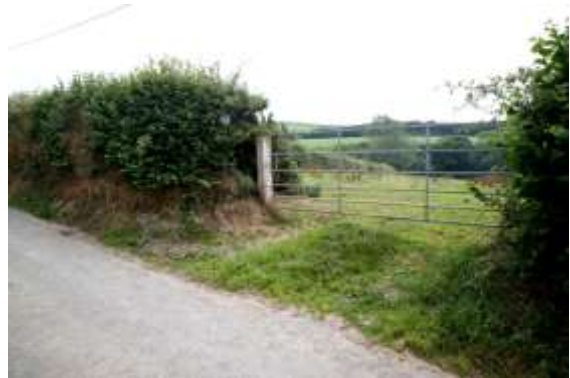
Path number:	564/1/1	Type:	Footpath	Category:	Silver	Date:	12/7/11
Approx Length (m):	554	Stiles/Gates:	3				
Route:	From Keywood to Road W of Froxton						
<p>Comments:</p> <p>There is no PF sign at the Keywood end of the path.</p> <p>The entrance to the path at Hilton Woods site has a security gate across it controlled by keypad. There is no defined pedestrian entrance although you can scramble around the gatepost with inconvenience. (photo 1)</p> <p>The path is well defined through Hilton Woods site with well maintained waymarks, tarmac roadways, trimmed grass path and trimmed hedges (photo 2).</p> <p>Near the boundary of the Hilton Woods site the path passes over a footbridge in satisfactory condition (photo 3), through a boggy area where a wooden walkway has been provided which is in satisfactory condition (photo 4).</p> <p>A further wooden walkway beyond is in poor condition. The stile at the boundary is in very poor condition with rotting timber and broken steps. There is a sign on the stile warning of a bull in the field. This is probably very old and not relevant. Misleading signs designed to deter the public are illegal. There is a further area of boggy ground beyond the stile which has no walkway (photo 5).</p> <p>The path continues through trees up a steep hill. The route is not easily visible (photo 6).</p> <p>Beyond the trees the path continues uphill into a field (pasture). The route is not visible on the ground, however it is possible to see the exit gate at the top right hand corner. Surface vegetation is satisfactory. A way marker where the path exits the trees would be beneficial (photo 7).</p> <p>There is a farm gate at the exit of the field at the road. This is in satisfactory condition (photo 8).</p> <p>There is a PF sign at the junction with the metalled road, visible now but could be prone to hedgerow overgrowth.</p>

<p>Recommendations:</p> <p>Investigate if security gate at Hilton Woods site has been authorised. I am surprised that if it has been authorised there is no provision for pedestrian access.</p> <p>PF sign required at Hilton Woods entrance.</p> <p>New stile and wooden walkways required. Remove misleading warning sign.</p> <p>Waymarking at exit of trees would be desirable.</p>

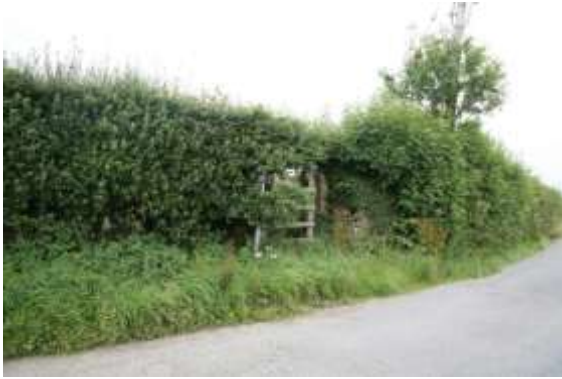
Photo 1

Path number:	564/2/1	Type:	Footpath	Category:	Silver	Date:	11/7/11
Approx Length (m):	426	Stiles/Gates:	2				
Route:	From Hillhead to road W of Bennetts						
Comments:	<p>PF sign at metalled road is visible now but could be subject to hedgerow obstruction (photo 1)</p> <p>The entrance gate is satisfactory although hedgerow and surface vegetation are encroaching (photo 2). The line of the path is not visible on the ground beyond the gate and it would benefit by waymarking</p> <p>The path continues over a field where the surface of the path has been ploughed and cropped (grass) which is calf high. In the past this path has been left unploughed /cropped and was much more convenient to walk (photo 3).</p> <p>The path continues to the field boundary where it turns to follow the hedgerow (headland path) (photo 4). This has been ploughed close to the boundary not leaving the minimum 1.5m for the path. Surface vegetation here is too high for walking. The path would benefit from waymarking at this point (photo 5).</p> <p>The path continues along the hedgerow to a metal farm gate in the corner. The gate is in good condition (photo 6).</p> <p>The path then enters Bennetts Court Holiday Cottages and continues over a metalled drive to the B3254 (photo 7).</p> <p>There is no PF sign at the B3254 main road (photo 8).</p>

Recommendations:	<p>Hedgerow and surface trimming required at the entrance gate (Hillhead). Strictly speaking it is not an offence to grow grass as a crop on the PRoW, however the landowner could be encouraged to avoid this practice so as to leave a visible and walkable path. Landholder should be required to reinstate the headland part of the path. The path would benefit from waymarking at the entrance gate and also at the field boundary on the west side. PF sign required at the Bennetts Court entrance on the B3254 metalled road.</p>

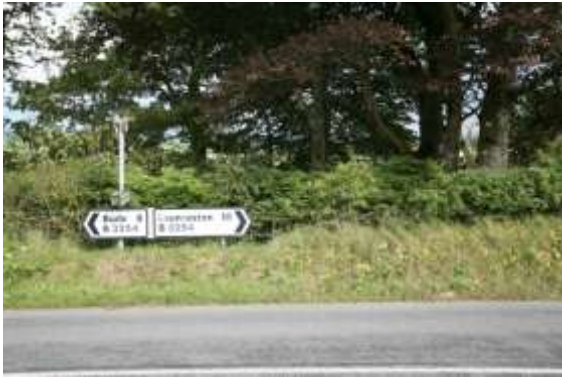
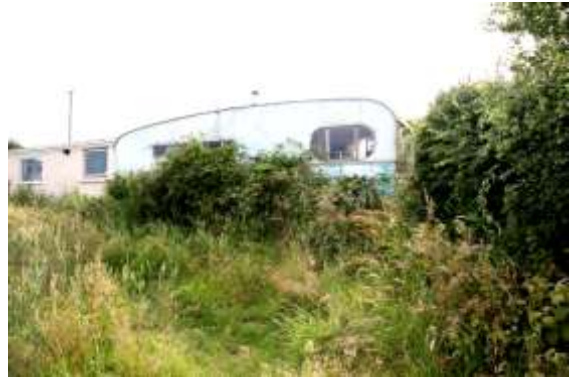
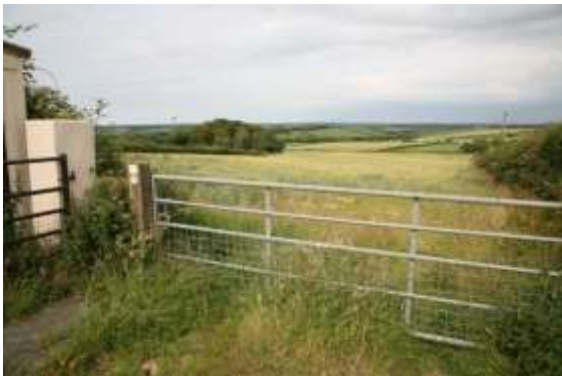
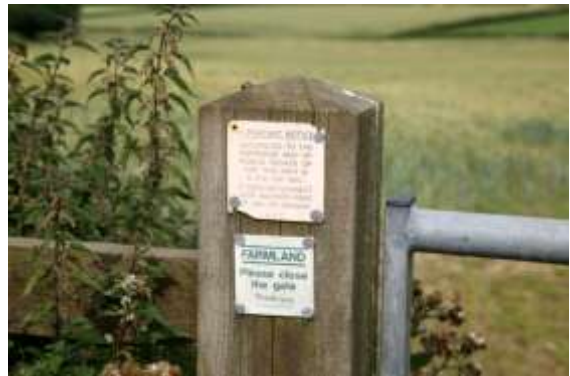
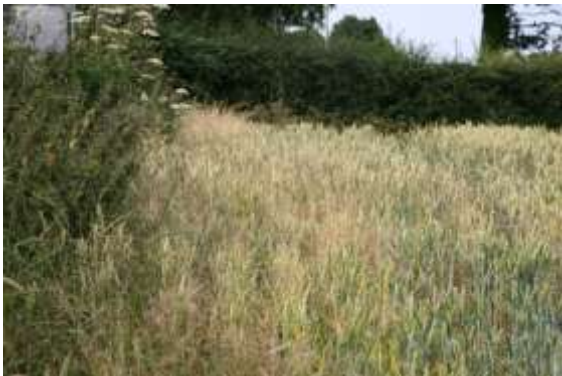
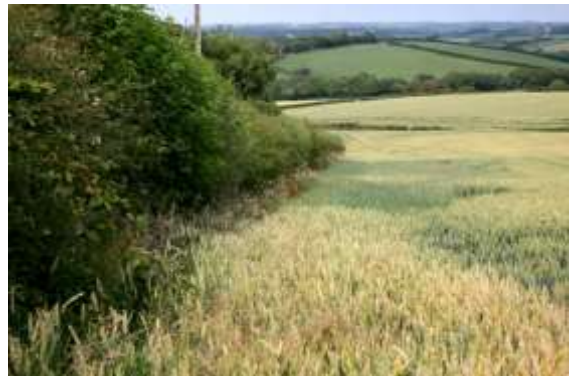
Path number:	564/3/1	Type:	Footpath	Category:	Silver	Date:	11/7/11
Approx Length (m):	955	Stiles/Gates:	?				
Route:	From Whitstone to Thorne (Green Lane Bungalow to Thorne Farm)						
Comments:	<p>The Definitive map shows this path starting through the property called Green Lane Bungalow. There is no entrance apparent at the point shown on the map (photo 1). There is a caravan in the property which appears to be across the line of the PRow as marked on the map (photo 2).</p> <p>There is no PF sign at this point or anywhere in the vicinity.</p> <p>There is a metal farm gate immediately to the south of Green Lane Bungalow (photo 3) which has a small notice on it (Cornwall County Council) indicating that the path is a cul-de-sac (i.e. not joining up with any other PRow) (photo 4).</p> <p>The gate is in satisfactory condition although surface vegetation makes it difficult to open/close.</p> <p>The path continues into a field. The field has been ploughed and cropped close to the boundary leaving no room for the path (headland path min. width 1.5m) (photo 5). Walking here was too difficult and I abandoned inspection of the path beyond this point (photo 6).</p>

Recommendations	<p>Investigate the situation at the entrance of this path. Either the Definitive Map is incorrect or the apparent route on the ground is incorrect. In either circumstance this should be corrected. PF sign requires at the metalled road (B3254).</p> <p>Owner(s) should be required to reinstate the headland parts of the path.</p>

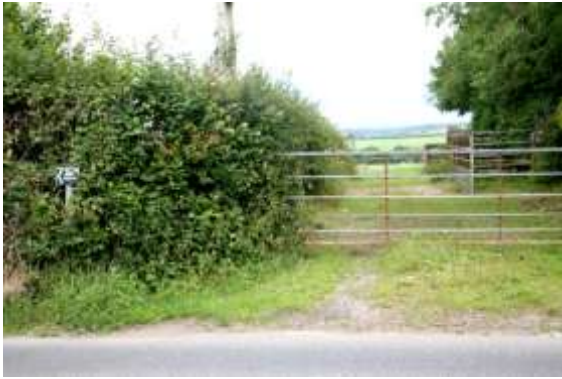
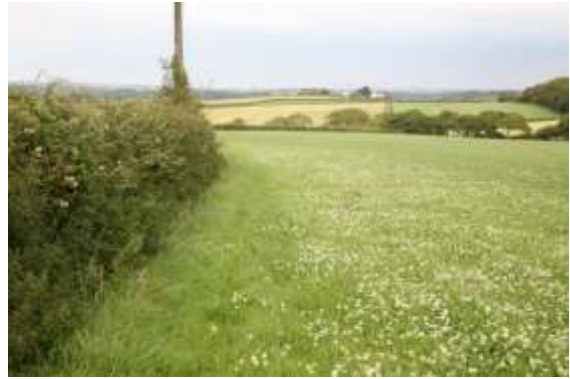
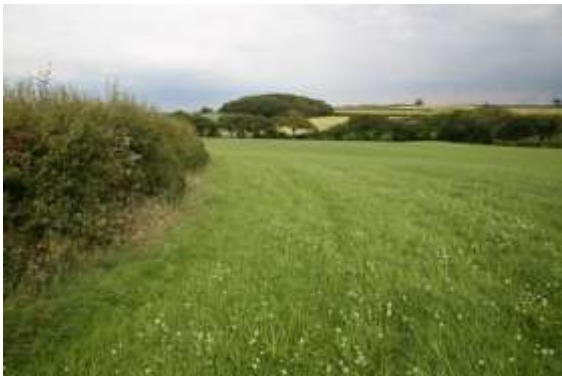
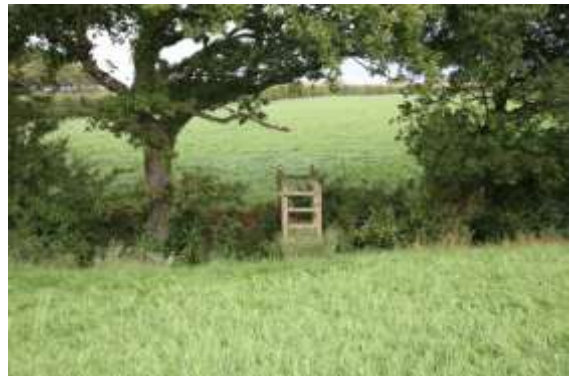
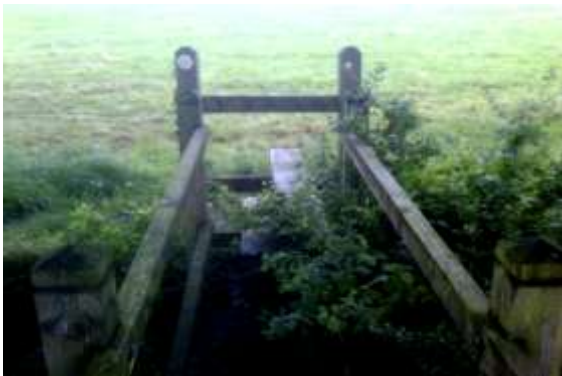
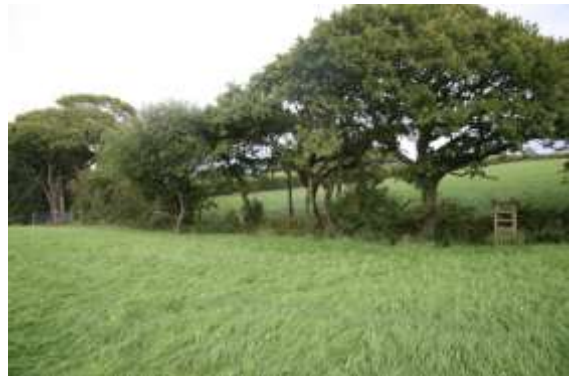
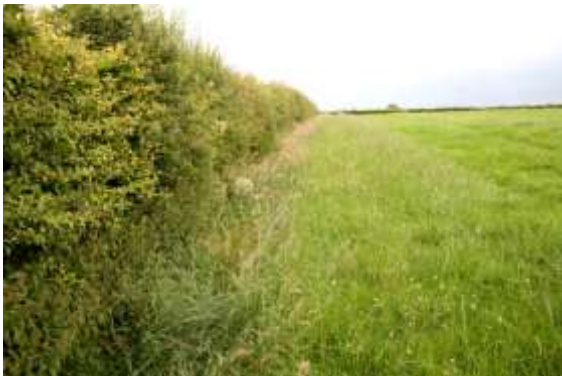
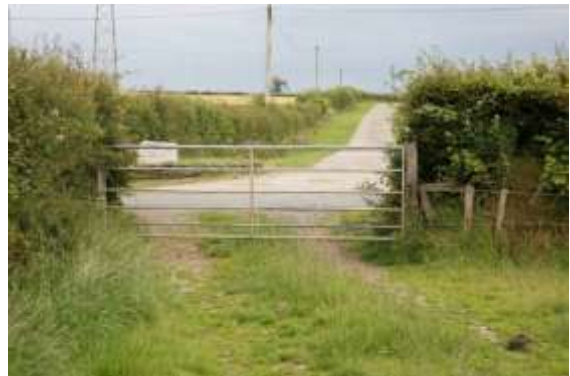
Path number:	564/4/1	Type:	Footpath	Category:	Silver	Date:	11/7/11
Approx Length (m):	695	Stiles/Gates:	6				
Route:	From road S of Whitstone to Road NW of West Balsdon (from opposite Oak Lane junc. To Balsdon Road opposite entrance to West Balsdon)						
Comments:	<p>There is a PF sign at the entrance to the path at the metalled road (B3254), however this has been turned around and now points in the wrong direction, it has also been slightly defaced (photo 1).</p> <p>There are a series of three metal farm gates at the entrance to the path, these are in fair condition although difficult to operate.</p> <p>The path continues along the boundary of the first field which has been ploughed and cropped (grass) close to the boundary not leaving room for the path (headland path minimum 1.5m) (photo 2). The path leaves the boundary to continue cross-field and could benefit from waymarking at this point (photo 3)</p> <p>The path continues cross-field to a footbridge on the east side. The grass is calf high but is walkable with difficulty.</p> <p>The footbridge has a stile at each end (photo 4). The footbridge and stiles are in satisfactory condition but there is some vegetation encroachment onto the footbridge (photo 5).</p> <p>The path and footbridge are quite close to a farm gateway which would be a much more convenient route for the path. This would do away with the need for a footbridge (and the maintenance of it) as well as avoiding the small amount of cross-field path in the next field. This would make cropping in the field more convenient for the landholder (photo 6). This could also get rid of the longer cross-field section and turn it into a headland path in the first field.</p> <p>The path continues to the next field boundary but could benefit from waymarking at this point.</p> <p>The path continues along the field boundary but surface vegetation and grass crop make walking difficult on the exact line of the path (headland path minimum 1.5m from boundary) (photo 7).</p> <p>The path exits the field via a metal farm gate at the Balsdon Road. The gate is in satisfactory condition (photo 8).</p> <p>There is no PF sign at this end of the path.</p>

Recommendations	<p>Repair/replace PF sign at junc with B3254.</p> <p>Owner(s) should be required to reinstate the headland parts of the path.</p> <p>Strictly speaking it is not an offence to grow grass as a crop on the PRoW, however the landowner could be encouraged to avoid this practice so as to leave a visible and walkable path.</p> <p>Investigate possibility of re-routing the path to get rid of footbridge and small length of cross-field path as well as the longer cross-field path in the first field.</p>

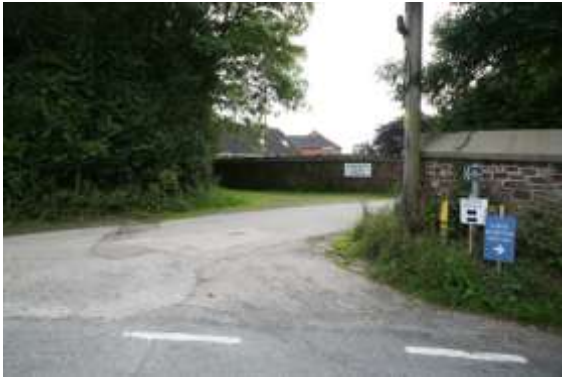
Photo 1

Path number:	564/5/1	Type:	Footpath	Category:	Silver	Date:	11/7/11
Approx Length (m):	205	Stiles/Gates:	2				
Route:	From Whitstone Head to St. Anne's Church						
<p>Comments:</p> <p>There is a PF sign at the metalled road on the opposite side to the path entrance (photo 1).</p> <p>The path runs down the side of Whitstone Head School boundary and at this point is in the form of a 'green lane'. The lane is well maintained with short surface grass and trimmed hedgerows. (photo 2) (photo 3). This leads to a 'kissing gate' at the entrance to a field (photo 4).</p> <p>The gate is in satisfactory condition however there are loose strands of barbed wire within the gate which could cause injury or damage to clothing (photo 5).</p> <p>The path continues across the field laid to grass pasture along an old hedge boundary. The surface vegetation is satisfactory (photo 6).</p> <p>The path continues to another 'kissing gate' at the entrance to the churchyard. This gate is in satisfactory condition (photo 7).</p> <p>The route on the Definitive Map ends at this point. I am not sure if a PRoW exists through the churchyard to Oak Lane, although a metalled path certainly exists and is in satisfactory condition.</p> <p>There is no PF sign at the Oak Lane end, however it is not a requirement if this is not a PRoW (photo 8).</p>

<p>Recommendations</p> <p>Landowners should be encouraged not to use barbed wire near gates/stiles. This is a requirement of BS 5709 2006.</p>

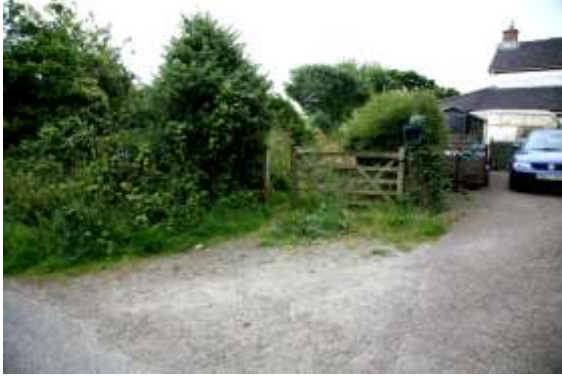
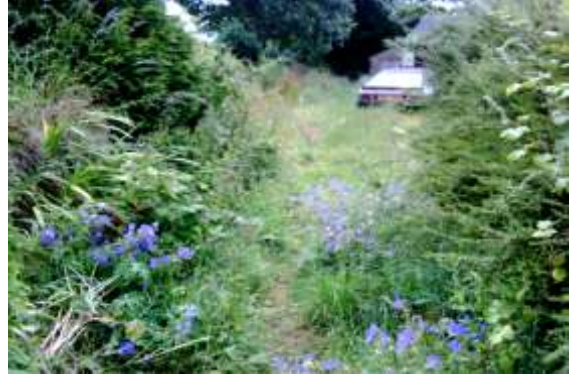
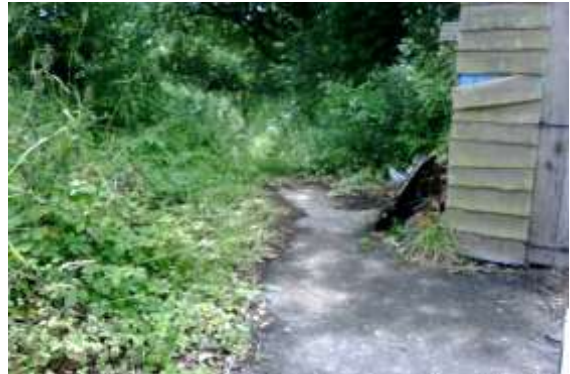
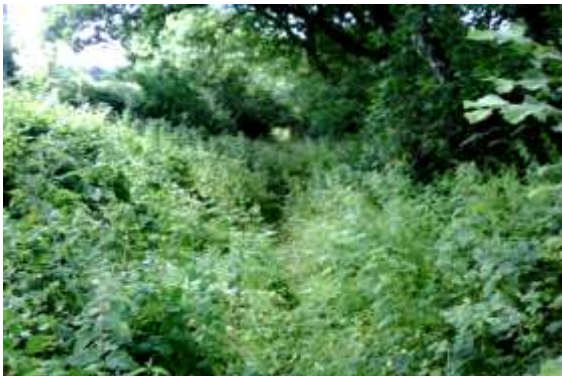
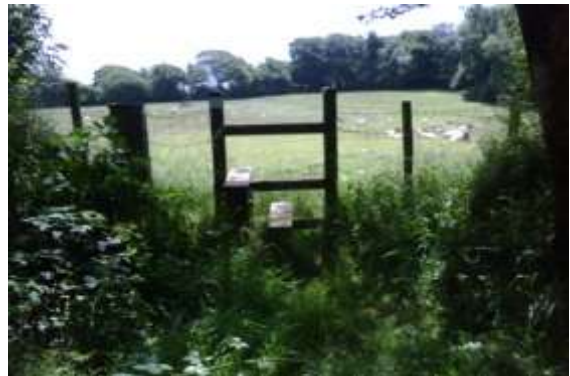
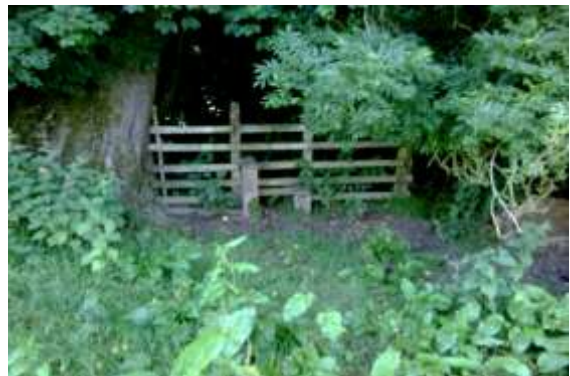
Path number:	564/6/1	Type:	Footpath	Category:	Silver	Date:	10/7/11
Approx Length (m):	715	Stiles/Gates:	8				
Route:	From Whitstone to road N of Bradborough (From Oak Lane to The Elms)						
Comments:	<p>There is a PF sign at the entrance in Oak Lane.</p> <p>The entrance to the path at is via a pedestrian gate which is in satisfactory condition (photo 1) although I am unsure if 'The Settlement' sign on the gate is legal, ownership of the 'green lane' requires investigation.</p> <p>The path then enters a 'green lane' alongside the boundary of 1 Gratton Cottages (The Settlement). The surface vegetation and hedgerows here require strimming and trimming. At this point the western boundary of the green lane is not well defined and there is an unused car and a shed in this area. It is possible to walk around the car and shed but it is not clear if they encroach on the PRoW. Further investigation would be required to establish this (photo's 2, 3, 4).</p> <p>The 'green lane' then continues downhill and at this point surface vegetation and hedgerow encroachment make walking difficult. It is not clear at this point whether the PRoW is the whole of the width of the green lane or may be just a minimum width path down the middle. Some quite sizable trees have grown up in the lane and would require removing if the PRoW is considered to be the whole width of the lane (photo 5). The 'green lane' ends at a stile (photo 6) which is in satisfactory condition with a waymark showing the route of the path across a field of grass as pasture. The surface vegetation is satisfactory at this point (photo 7)</p> <p>The path continues via a stile (photo 8) into the property called Trelawne. The path at this point is under trees and the surface and hedgerow vegetation is satisfactory (photo 9).</p> <p>The path continues over the driveway and via a stile in good condition (photo 10) into the grounds of St. Anne's Parish Hall, the surface at this point was recently washed away by rain but has since been restored with gravel and is in satisfactory condition.</p> <p>The path continues via a gate (photo 11) in good condition over a gravel path in St. Anne's Close to a stile (photo 12) in satisfactory condition. The path then enters a field with calf-high grass crop and via a cross-field path to a stile in the top corner of the field (photo 13). The line of the path is not visible on the ground due to cropping but the stile on the far side is visible.</p> <p>The stile is in satisfactory condition (photo 14) and leads into the next field of grass pasture and along the eastern boundary of the field (photo 15). The surface here is satisfactory.</p> <p>The path leaves the field via a pedestrian gate in good condition and over the metalled drive of The Elms onto the metalled road (photo 16).</p> <p>There is a PF sign at this point.</p> <p>Recommendations</p> <p>Investigate the ownership and exact boundary of the 'green lane' at the Oak Road end of the path. Define the boundary with a fence or other barrier so as to prevent any encroachment on the PRoW.</p> <p>The 'green lane requires considerable surface and hedgerow trimming involving cutting down of young trees and undergrowth.</p> <p>Strictly speaking it is not an offence to grow grass as a crop on the PRoW, however the landowner could be encouraged to avoid this practice so as to leave a visible and walkable path.</p>

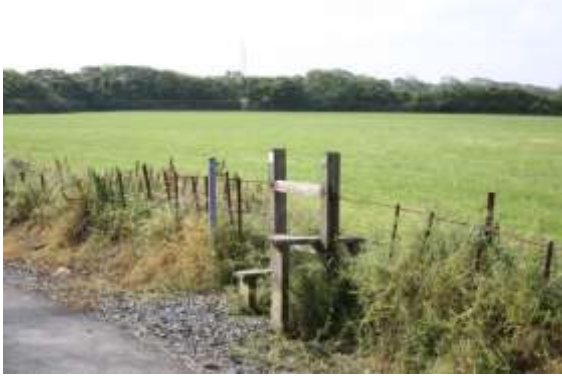
Photo 1

Path Number:	564/7/1	Type:	Footpath	Category:	Silver	Date:	11/7/11
Approx Length (m):	828	Stiles/Gates:	2				
Route:	From Bradborough to Nethercott						
<p>Comments:</p> <p>There is a PF sign at the entrance to this path.</p> <p>The path enters a field laid to grass crop via a stile which is in satisfactory condition (photo 1). The path continues cross-field and the grass is short. The line of the path is not visible on the ground but it is just possible to see the stile on the far side.</p> <p>The path continues over the stile (photo 2), which is in satisfactory condition but requires surface and hedgerow trimming, into a 'green lane' which is almost completely choked with surface undergrowth of bracken, bramble and grass for the next 200m or so (photo 3). The path is walkable with difficulty via two narrow tractor tracks where the surface vegetation is reduced.</p> <p>There is a strand of binder twine across the path at this point presumably to control stock (photo 4). After this point the surface is farm track and hedgerows are satisfactory (photo 5).</p> <p>The path continues into Nethercott Farm where there is a further strand of twine across the path (photo's 6, 7) and onwards via the track and concrete surface to the metalled road (photo 8).</p>

<p>Recommendations:</p> <p>Strictly speaking it is not an offence to grow grass as a crop on the PRow, however the landowner could be encouraged to avoid this practice so as to leave a visible and walkable path.</p> <p>The Stile and 'green lane' require substantial trimming of surface and hedgerow vegetation.</p> <p>The owner should be encouraged to remove the strands of twine across the path.</p>

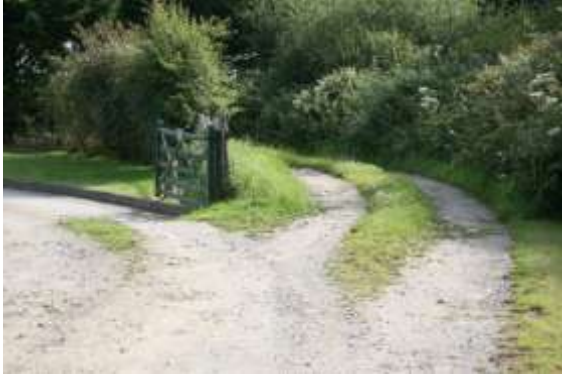
Photo 1

Path Number:	564/8/1	Type:	Footpath	Category:	Silver	Date:	11/7/11
Approx Length (m):	307	Stiles/Gates:	5				
Route:	From Nethercott to Road near Street						
<p>Comments:</p> <p>The path starts from the driveway of Nethercott Farm and continues via a gated drive of a property with metalled drive (photo 1) then shortly bears right over a stile in good condition (photo 2) to a farm track. The path is waymarked at the stile.</p> <p>The path then continues through a gateway. The gateway has been blocked by three metal gates strapped together with twine and cable-ties. The structure is very flimsy and unsafe to climb over (photo's 3, 4).</p> <p>The path continues beside a pond (photo 5) and follows the southern field boundary. The field is grass pasture and surface is satisfactory (photo 6).</p> <p>The path then reaches the SE corner of the field where there are 2 stiles only a short distance apart ,(less than 3m). The first stile has an electric fence across it and is quite flimsy (photo 7). There is a lot of surface and hedgerow vegetation between the two stiles such as to make it almost impassable.</p> <p>The second stile leads to the busy and dangerous B3254 through Street opposite Cherrymoor (photo 8).</p> <p>There is a PF sign at this point.</p>

<p>Recommendations:</p> <p>Require landholder to remove the blockage to the PRoW caused by the barrier of three gates tied together.</p> <p>Hedgerow and surface trimming required in SE corner of field and the stiles at junc with B3254 at Street.</p> <p>Landholder should be encouraged to make more suitable arrangement for stock control at this stile.</p>

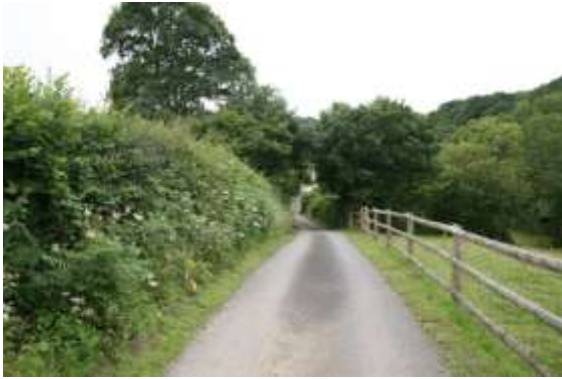
Photo 1

Path Number:	564/9/1	Type:	Footpath	Category:	Silver	Date:	11/7/11
Approx Length (m):	700	Stiles/Gates:	1				
Route:	From Parish boundary (Oddmill) to road E of Hilton Wood						
Comments:	<p>There is no sign to indicate the Parish Boundary.</p> <p>The path enters Whitstone Parish from Week St Mary a short distance west of Oddmill (photo 1). At this point it is a metalled surface track between fences or hedgerow all in good condition.</p> <p>The path continues on a metalled road to a farm gate across the road which looks as though it is permanently open (photo's 2, 3) and continues through the woods (photo's 4, 5) past Hilton House (photo 6) and onward to meet the road (photo's 7, 8). All is in good condition.</p> <p>There is a PF sign where the path exits onto the metalled road.</p>						
Recommendations:	None

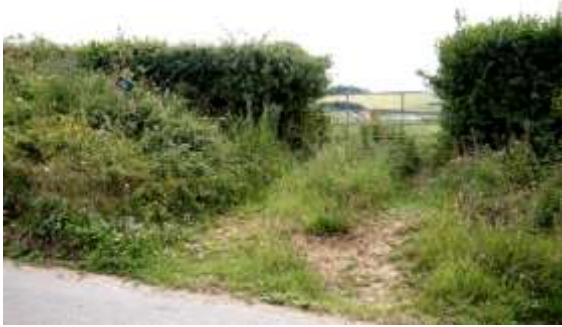
Photo 1

Path Number:	564/10/1	Type:	Footpath	Category:	Silver	Date:	11/7/11
Approx Length (m):	387	Stiles/Gates:	3				
Route:	From Froxton to Luckham						
<p>Comments:</p> <p>There is a PF sign at the entrance to the path at the metalled road.</p> <p>The path is entered via a metal farm gate (photo 1) and continues over a field of grass crop on a cross-field path (photo 2) to a stile in the SE corner. The stile is not level but is otherwise in satisfactory condition (photo 3). However the hedgerow requires trimming at this point.</p> <p>The path continues downhill in a field laid to grass pasture to a bridge over a stream (photo 4) and then uphill through a further pasture to a metal gate into a farm track (photo 5). The surface vegetation over these two fields and the farm track is satisfactory.</p> <p>The path then continues into the farmyard over concrete surface through a shed/canopy (photo 6), onward between farm buildings (photo 7) to meet the metalled road (photo 8).</p> <p>There is a PF sign at this point in the hedge on the opposite side of the road. This is partially obscured by the hedgerow vegetation.</p>

<p>Recommendations:</p> <p>Strictly speaking it is not an offence to grow grass as a crop on the PRoW, however the landowner could be encouraged to avoid this practice so as to leave a visible and walkable path.</p> <p>Investigate if the shed/canopy at Luckham is built over the footpath and establish if this is an allowable development. It does not necessarily impede progress over the PRoW.</p>

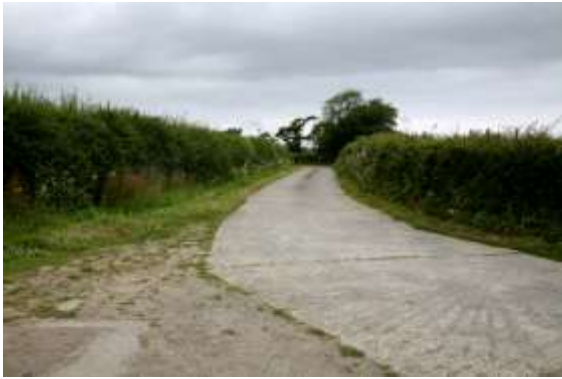
Photo 1

Path Number:	564/11/1	Type:	Footpath	Category:	Bronze	Date:	12/7/11
Approx Length (m):	80	Stiles/Gates:	0				
Route:	From Parish boundary to Parish boundary SW of Higher Westcott (This is a short piece of a WSM path which just crosses the Parish Boundary)						
Comments:	<p>This is a short middle section of a path which is basically in Week St Mary Parish. It consists of a concrete farm track with grass verges and hedgerows (photo 1). It is in satisfactory condition and presumably is maintained by owners of the land as they maintain the rest of the track.</p>						
Recommendations:	None
